CATE Center ROV Team Technical Report

ROV - Thresher

This technical report summarizes the design, testing, and construction of the CATE center ROV. Our intention upon the outset of this endeavor was to have the opportunity to compete at the national level. Fortunately, the knowledge we have gained about underwater systems has allowed us to progress to the 2005 MATE Center/MTS National ROV Competition.

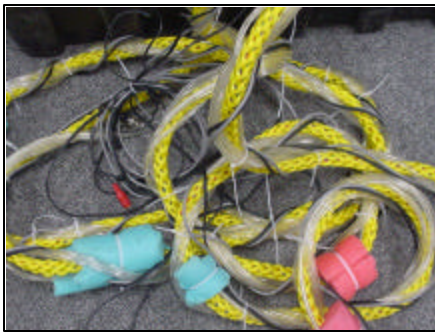
Our tether is 13 meters long and composed of poly threaded line sheathing the eight 16 gauge coated wires, supplying power to the four motors. The wires are connected to a junction box on the exterior of the control box to minimize the stress on the connections inside. All connections in and on the control box use spade connectors. On the ROV itself there is no junction box, all connections run to a 9 pin plug (we only used 8) while the poly line is glued with marine putty to a 1" screw in PVC connector so that the tether can be disconnected for travel. The wire connections to the motors are soldered and sealed using heat shrink wraps.

The six air lines used to power our pneumatics and two television cables are attached to the exterior of the tether by 12" zip ties placed approximately every two feet. It was concluded that to fit all the wires, cables, and air lines would make the tether much stiffer and could impede the mobility of the ROV.

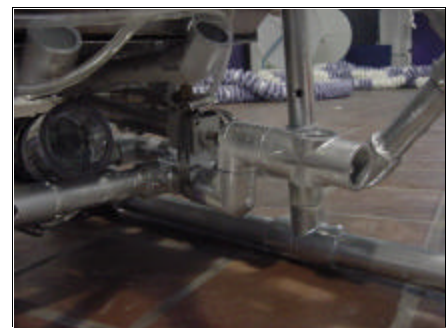
To attach the patch to the Hubble Space Telescope, we must first attach it to our ROV. We do this with a PVC coupling that holds it securely in place. Since the patch is now mounted in the front of our ROV, we

can easily drive up to the target and connect it using only the front camera. Once we get the patch hooked onto the telescope, we must disengage it from the ROV. To accomplish this, we mounted a pneumatic cylinder, with a ram that runs into the PVC coupling. When triggered topside, the ram will then quickly, and easily disengage the patch from our ROV.

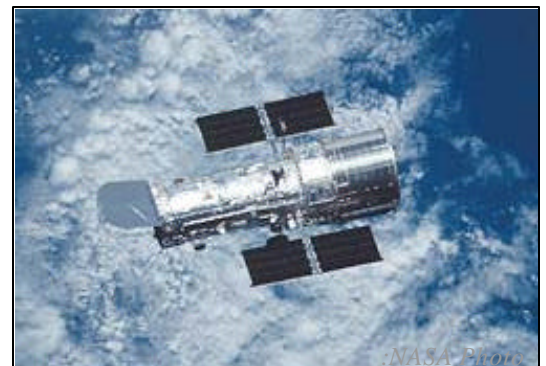
The Hubble Space Telescope was launched into orbit by the space shuttle *Discovery* in 1990 for the express purpose of gathering images of distant galaxies and celestial bodies that were not possible with earth bound equipment. Soon after its launch, however, a flaw was discovered with its main gathering mirror. This flaw was remedied with the installation of new components during a series of repair missions in 1993, 1997, 1999, and 2002.

The Hubble Space Telescope's orbit lies approximately 380 miles above the earth which allows it to take extremely clear pictures because it is not hampered by the distortion of the earth's atmosphere. The Hubble Telescope utilizes two separate instrument packages, imagers, which snap pictures of objects and spectrographs which interprets light waves. The imagers convert light to electronic signals which are then transmitted to the ground to the control station at NASA's Goddard Space Flight Center or to the European Space Agency (ESA). The spectrograph

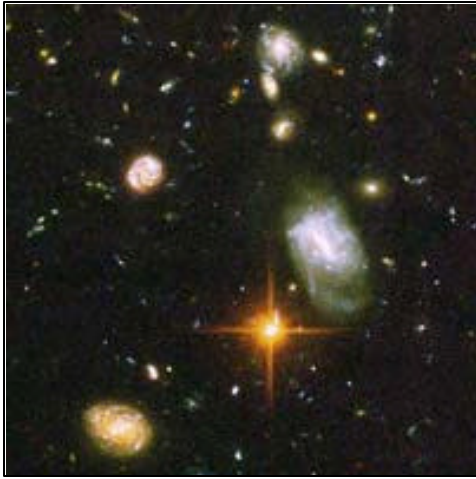
NASA Photo: Hubble Ultra Deep Field

light originates from disks around black holes, and exploding stars. Infrared light data is analyzed and yields information on calmer events, such as the formation of dust clouds around stars.
