2011

PEARL CITY HIGH/HIGHLANDS INTERMEDIATE SCHOOL PEARL CITY, HI

KAIMANA ENTERPRISES

This technical report illustrates the electrical and structural design of our ROV, the challenges we faced, the lessons we learned, and the financial report for our company. We have also included background information on the Deepwater Horizon oil spill, and photographs of our steps to success.

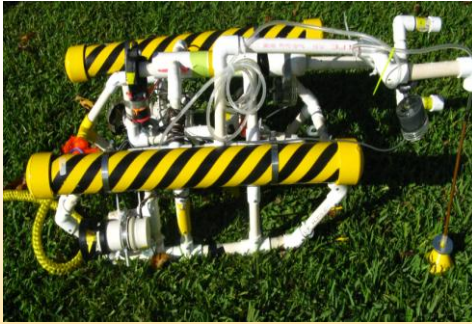
Figure 1: Photo of our ROV (top view)

The frame of the ROV is constructed with PVC pipes and ABS pipes to create neutral buoyancy. The ROV is composed of a left and a right motor for lateral movement, an additional motor with two propellers for vertical movements, one car door actuator to operate the grabber, and a power window motor to control the rotating arm. We used three cameras to guide our ROV as well as to provide visibility for the grabber and rotating arm to accomplish the missions.

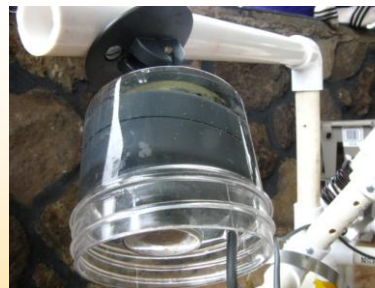
Figure 5: Camera to see claw/rotating arm

One camera is mounted above the ROV to see the claw/rotating arm (Fig. 5). Another

camera is mounted in the middle bottom and aimed toward the front of the ROV to see the front of the ROV and to make sure the crustaceans are collected in Task 4. The final camera is mounted on the sheath over the rotating arm to focus on the rotating arm on the ROV for Task 2.

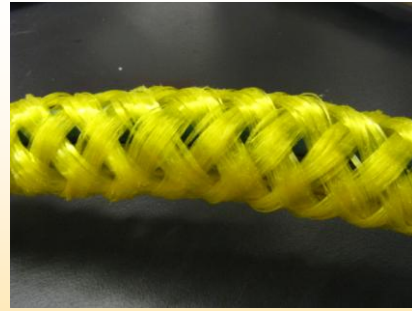
Figure 6: Tether covered with hollow braid rope for buoyancy

We worked on the tether next, since we were done wiring the ROV with the CAT-5s and the camera wires. The tether consists of two insulated CAT-5 wires that control the motors, the claw, and the rotating arm from the control box. Along with the CAT-5 wires, the tether includes a 0.3 cm air line used for Task 3, collecting a water sample, and three lines for cameras (Fig. 6). These five lines are held together in a sheath of 100 feet of polypropylene hollow braid rope. The rope is positively buoyant to counteract the negative buoyancy of the cables.

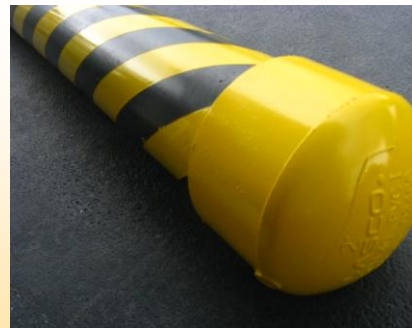
Figure 7: ABS capped pipe

We tested buoyancy next in the water. The ROV achieved buoyancy using capped ABS pipes filled with air (Fig. 7). We wished to achieve neutral buoyancy, when an object does not float or sink in a body of liquid, or to achieve slightly negative buoyancy so the ROV would descend faster. In order to find the volume of air required to achieve neutral buoyancy, a system of five 500 mL empty plastic bottles was attached to the center of the ROV and removed one at a time until the ROV became neutrally buoyant. To calculate the exact dimensions of ABS pipes, we used the total volume of air required to compensate for the ROV, 2,000 mL, and plugged in the different sizes of ABS pipes, 3" and 2", into the formula

$V = \pi r^2 d$ to find the different length of ABS pipe needed. We chose the 2" radius pipes over the 3" pipes because the 2" by 2' ABS pipes was the length of the ROV. The ABS pipe is capped and sealed with waterproof coating and PVC caps and attached to the top of the ROV.

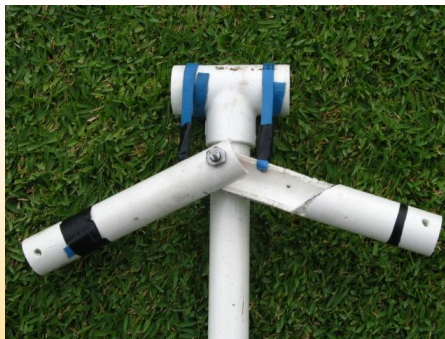
Figure 10: Clip for the U-bolt (top view)

We created a clip to attach to the U-bolt (Fig. 10). The front of this clip is a PVC Tee which guides the attachment through the U-bolt. The clip is constructed using two hinges of PVC held together by a 10-24

threaded rod on another PVC pipe. Two elastic bands and a spring allow the clip to push through the opening in the U-bolt and to open and lock in place once through the U-bolt. A line attached to the coupling on the long PVC pipe is mounted onto the ROV over the claw using a special PVC mount. Once the clip locks in place on the U-bolt, the driver will reverse the ROV, causing the PVC pipe to detach and to remain in place on the U-bolt. A company member on deck holds the line taut.

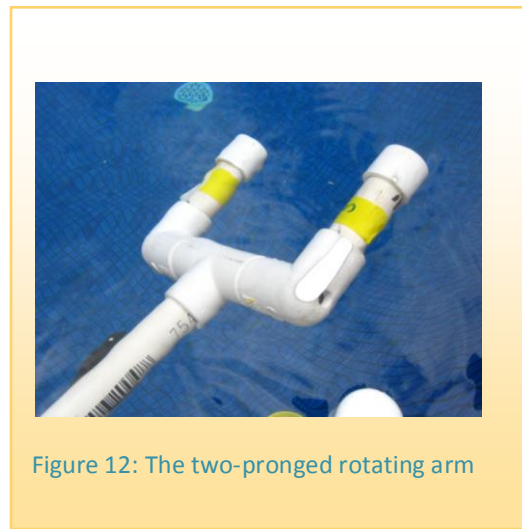
Figure 12: The two-pronged rotating arm

The claw attachment is used in this task to pick up and insert the hose line into the wellhead. Once this is completed, a two-pronged arm of PVC pipe turns the wheel (Fig. 12).

The driver drives the two-pronged arm of PVC pipe into the wheel, and the power

window motor rotates the arm in a counterclockwise motion, rotating the wheel. When the wheel has been rotated 1080 degrees, the driver backs out of the wheel, having successfully shut off the well.

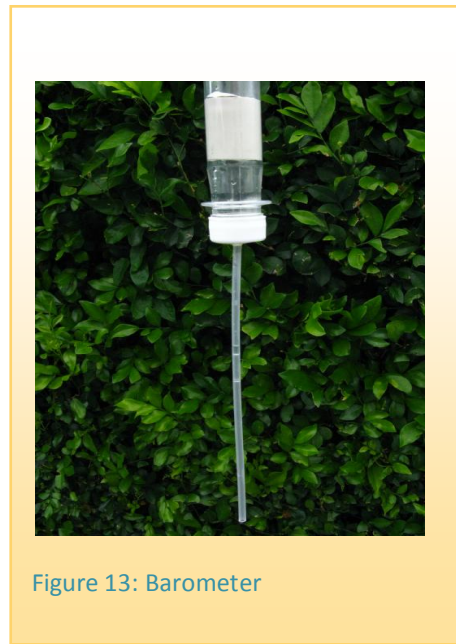
Figure 13: Barometer

To determine depth in the water, we attached the barometer as a payload on our ROV (Fig. 13). The barometer consists of a deflated soda bottle with a clear tube inserted into the cap. We attached this upside-down to the ROV with cable ties and placed weights at the bottom of the test tube to ensure that the barometer stays perpendicular to the bottom of the pool. As the ROV drives into the pool, the water pressure increases and causes the water level to rise at the bottom of the straw up toward the plastic bottle. We calibrated and marked off different depths and placed a small Styrofoam ball in the clear tube to help us quickly determine the marker.

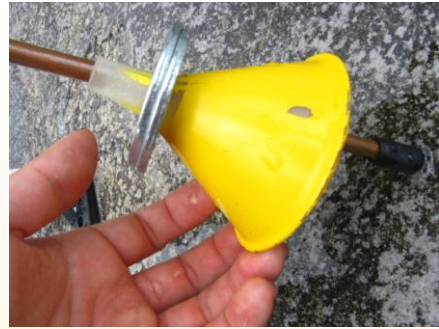
Figure 14: Sample collector (metal tube end)

After the depth of the ROV is determined and matches the depth we interpreted using the graph, the driver inserts the copper air line end of the water sample collector into the well (Fig. 15). This consists of an upside-down funnel and weights strung onto

a hollow copper rod (Fig. 14). Electrical tape at the bottom of the rod holds the funnel to the rod. The structure is held in place on the ROV with a sample collector holder made of PVC (Fig. 15) that extends into the plastic air line to the water sample container pump on deck. The rod keeps the line stiff and the funnel decreases time by allowing a larger guessing area for the driver to drive the rod into the water sample container.

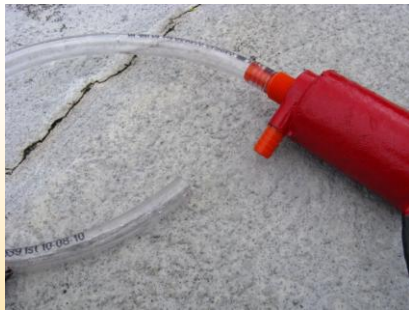
Figure 16: Water sample collector (pump end)

The other end of the water sample collector on the air line tubing consists of the water sample collector pump which is a car window washer pump (Fig. 16). The air line

on one end pulls water into the pump and the pump pushes this water out of the pump on the other end. A company member on deck turns the collector on, running the pump, to push water through the pump back into the pool, until the desired sample water runs through the air line. At this time, the team member places a designated water sample collector container under the pump and proceeds to collect the sample water.
